Manhole Inspection Summary

Manhole # S39G__008MH

Location Address: **e lombard st**

Cross Street: **s. albemarle st**

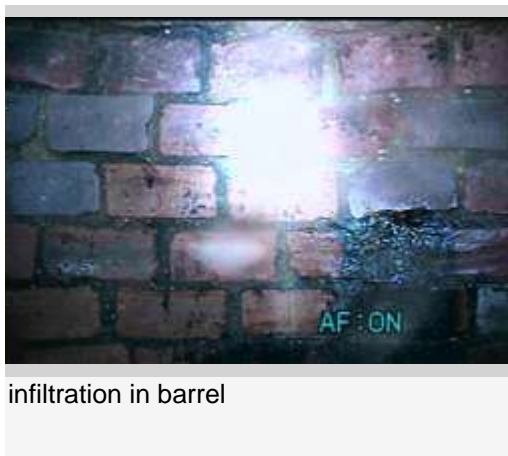
Defect 3

Infiltration: ☐ None ☐ Joint ☐ Cracks ☐ Mortar ☐ Roots ☒ **Wall**

infiltration in barrel

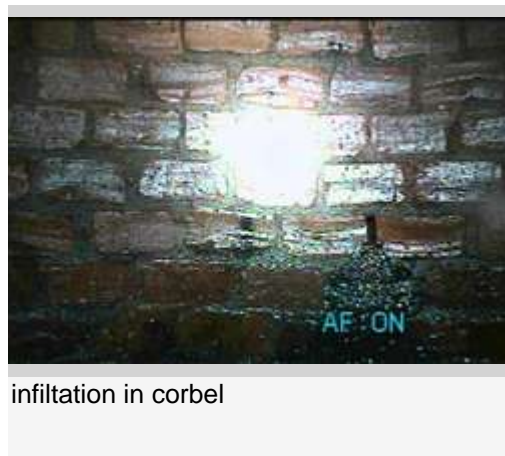
Defect 2

Infiltration: ☐ None ☐ Joint ☐ Cracks ☐ Mortar ☐ Roots ☒ **Wall**

infiltration in corbel

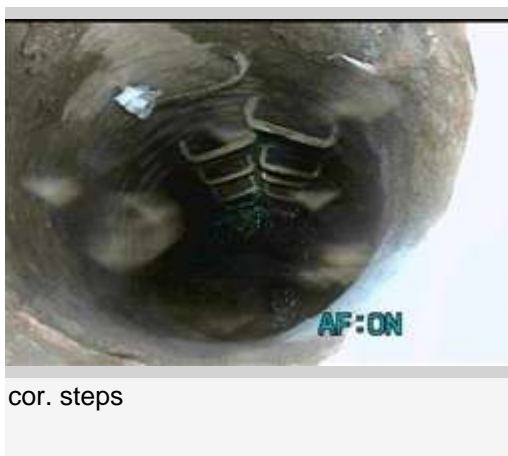
Defect 1

Count: **11** Missing: **1** ☒ **Corroded**

cor. steps

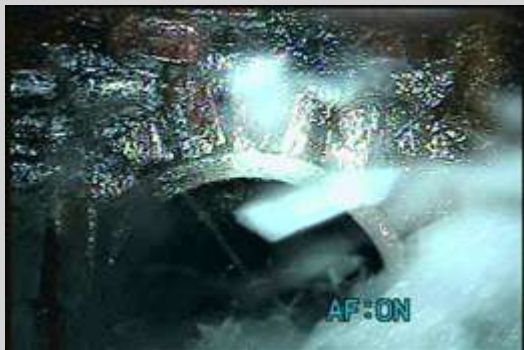
12 O'Clock Outflow

cant get better pic due to turbulent flow of the
9
